RE: Farm Ponds Area Groundwater Remedial Action Progress Summary – Year 2018

Technical Memorandum

To: Noel Mak/ATI Millersburg Operations
From: Renee Fowler/GSI Water Solutions, Inc.
Kathy Roush/GSI Water Solutions, Inc.
Date: March 29, 2019
Re: **Farm Ponds Area Groundwater Remedial Action Progress Summary – Year 2018**

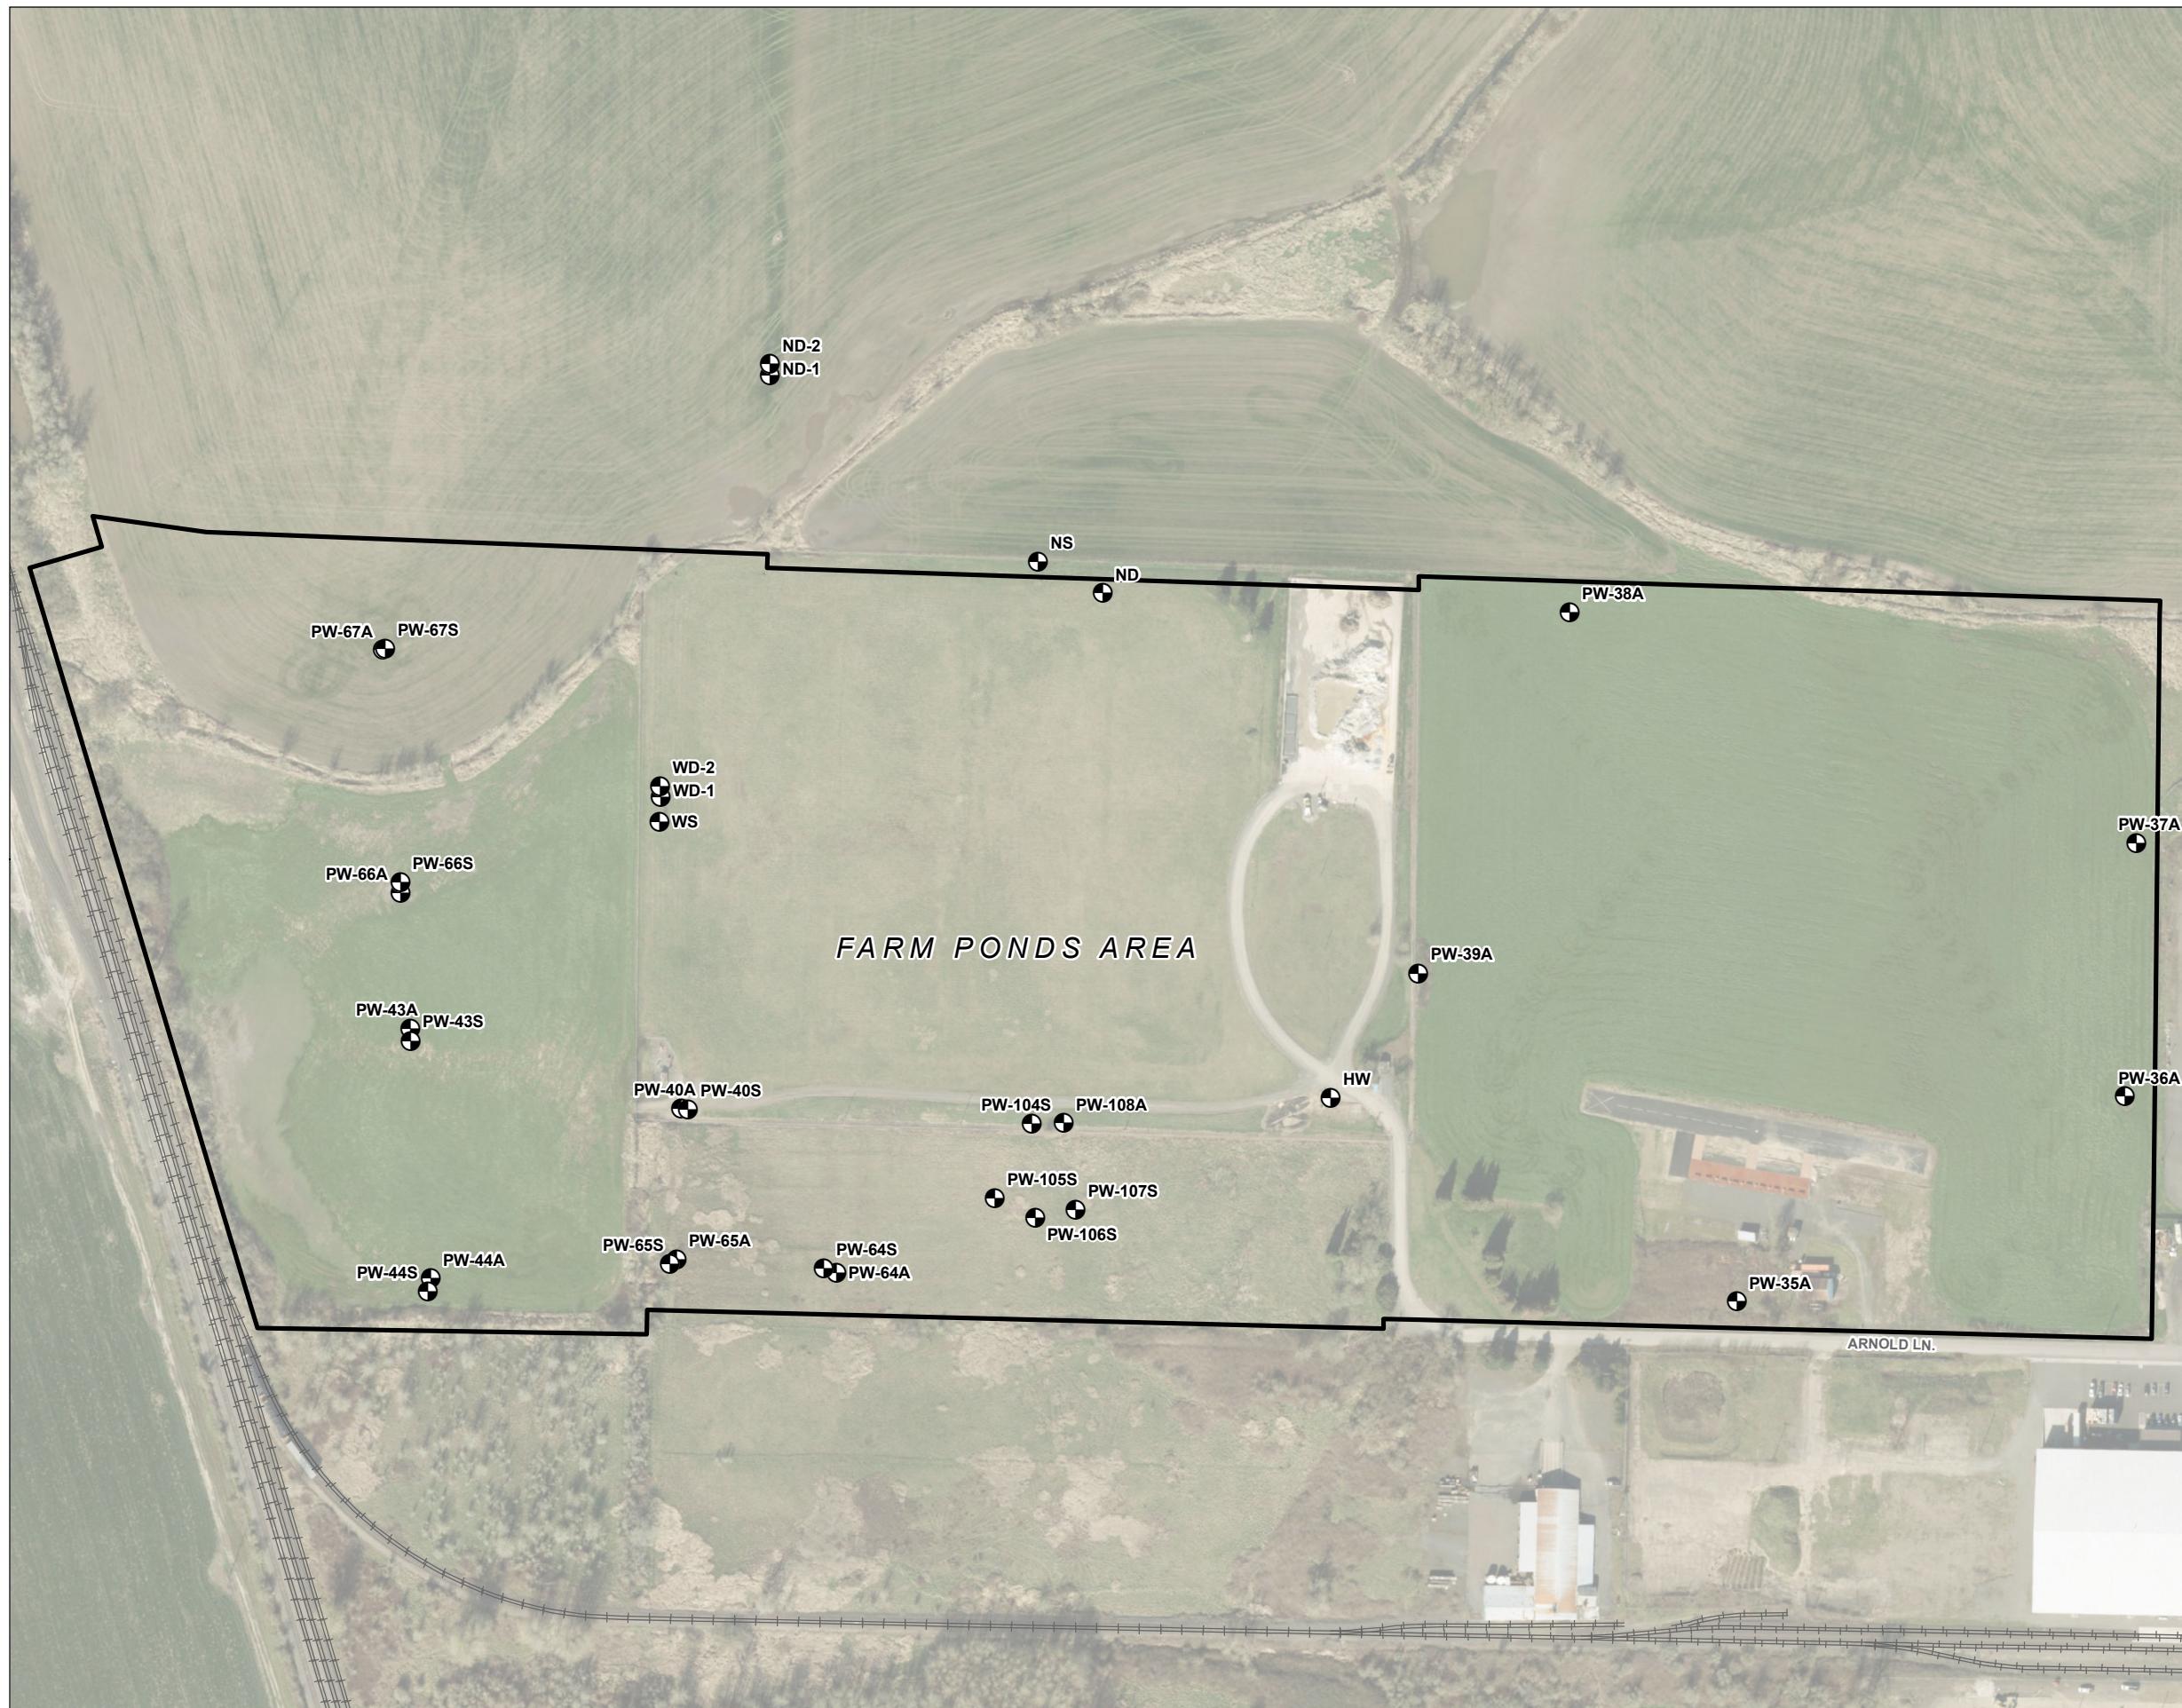
FIGURE 1

The Farm Ponds Area consists of 32 monitoring wells (Figure 1). Monitoring wells with an 'A' designation are completed in the Linn Gravel hydrostratigraphic unit, which is considered the uppermost water-bearing unit. Monitoring wells designated with an 'S' are completed in the Willamette Silt hydrostratigraphic unit. This silt is the fine-grained material that mantles much of the mid-Willamette Valley. The silt is seasonally saturated in most areas and yields low quantities of groundwater to wells, typically less than one gallon per minute. Well construction details are in Attachment A.

Farm Ponds Area Monitoring Wells
ATI Millersburg Operations, Oregon

PW-104S lies on the southern boundary of the old removed Farm Ponds (see Figure 1). The ATI property boundary lies approximately 300 feet to the south of PW-104S and 1,100 feet to the west of PW-104S. The Explanation of Significance Difference (ESD) for the ROD, issued by EPA on October 8, 1996, addressed the need for clarification in the requirements for the Farm Ponds Area in Section 4.2. It begins by stating, *"The ROD provides apparently inconsistent requirements for groundwater in the Farm Ponds."* It clarifies this inconsistency by stating that, *"For consistency with the rest of the site, EPA has changed the point of compliance to the property boundaries in the Farm Ponds Area."* The property boundary is shown in Figure 1.

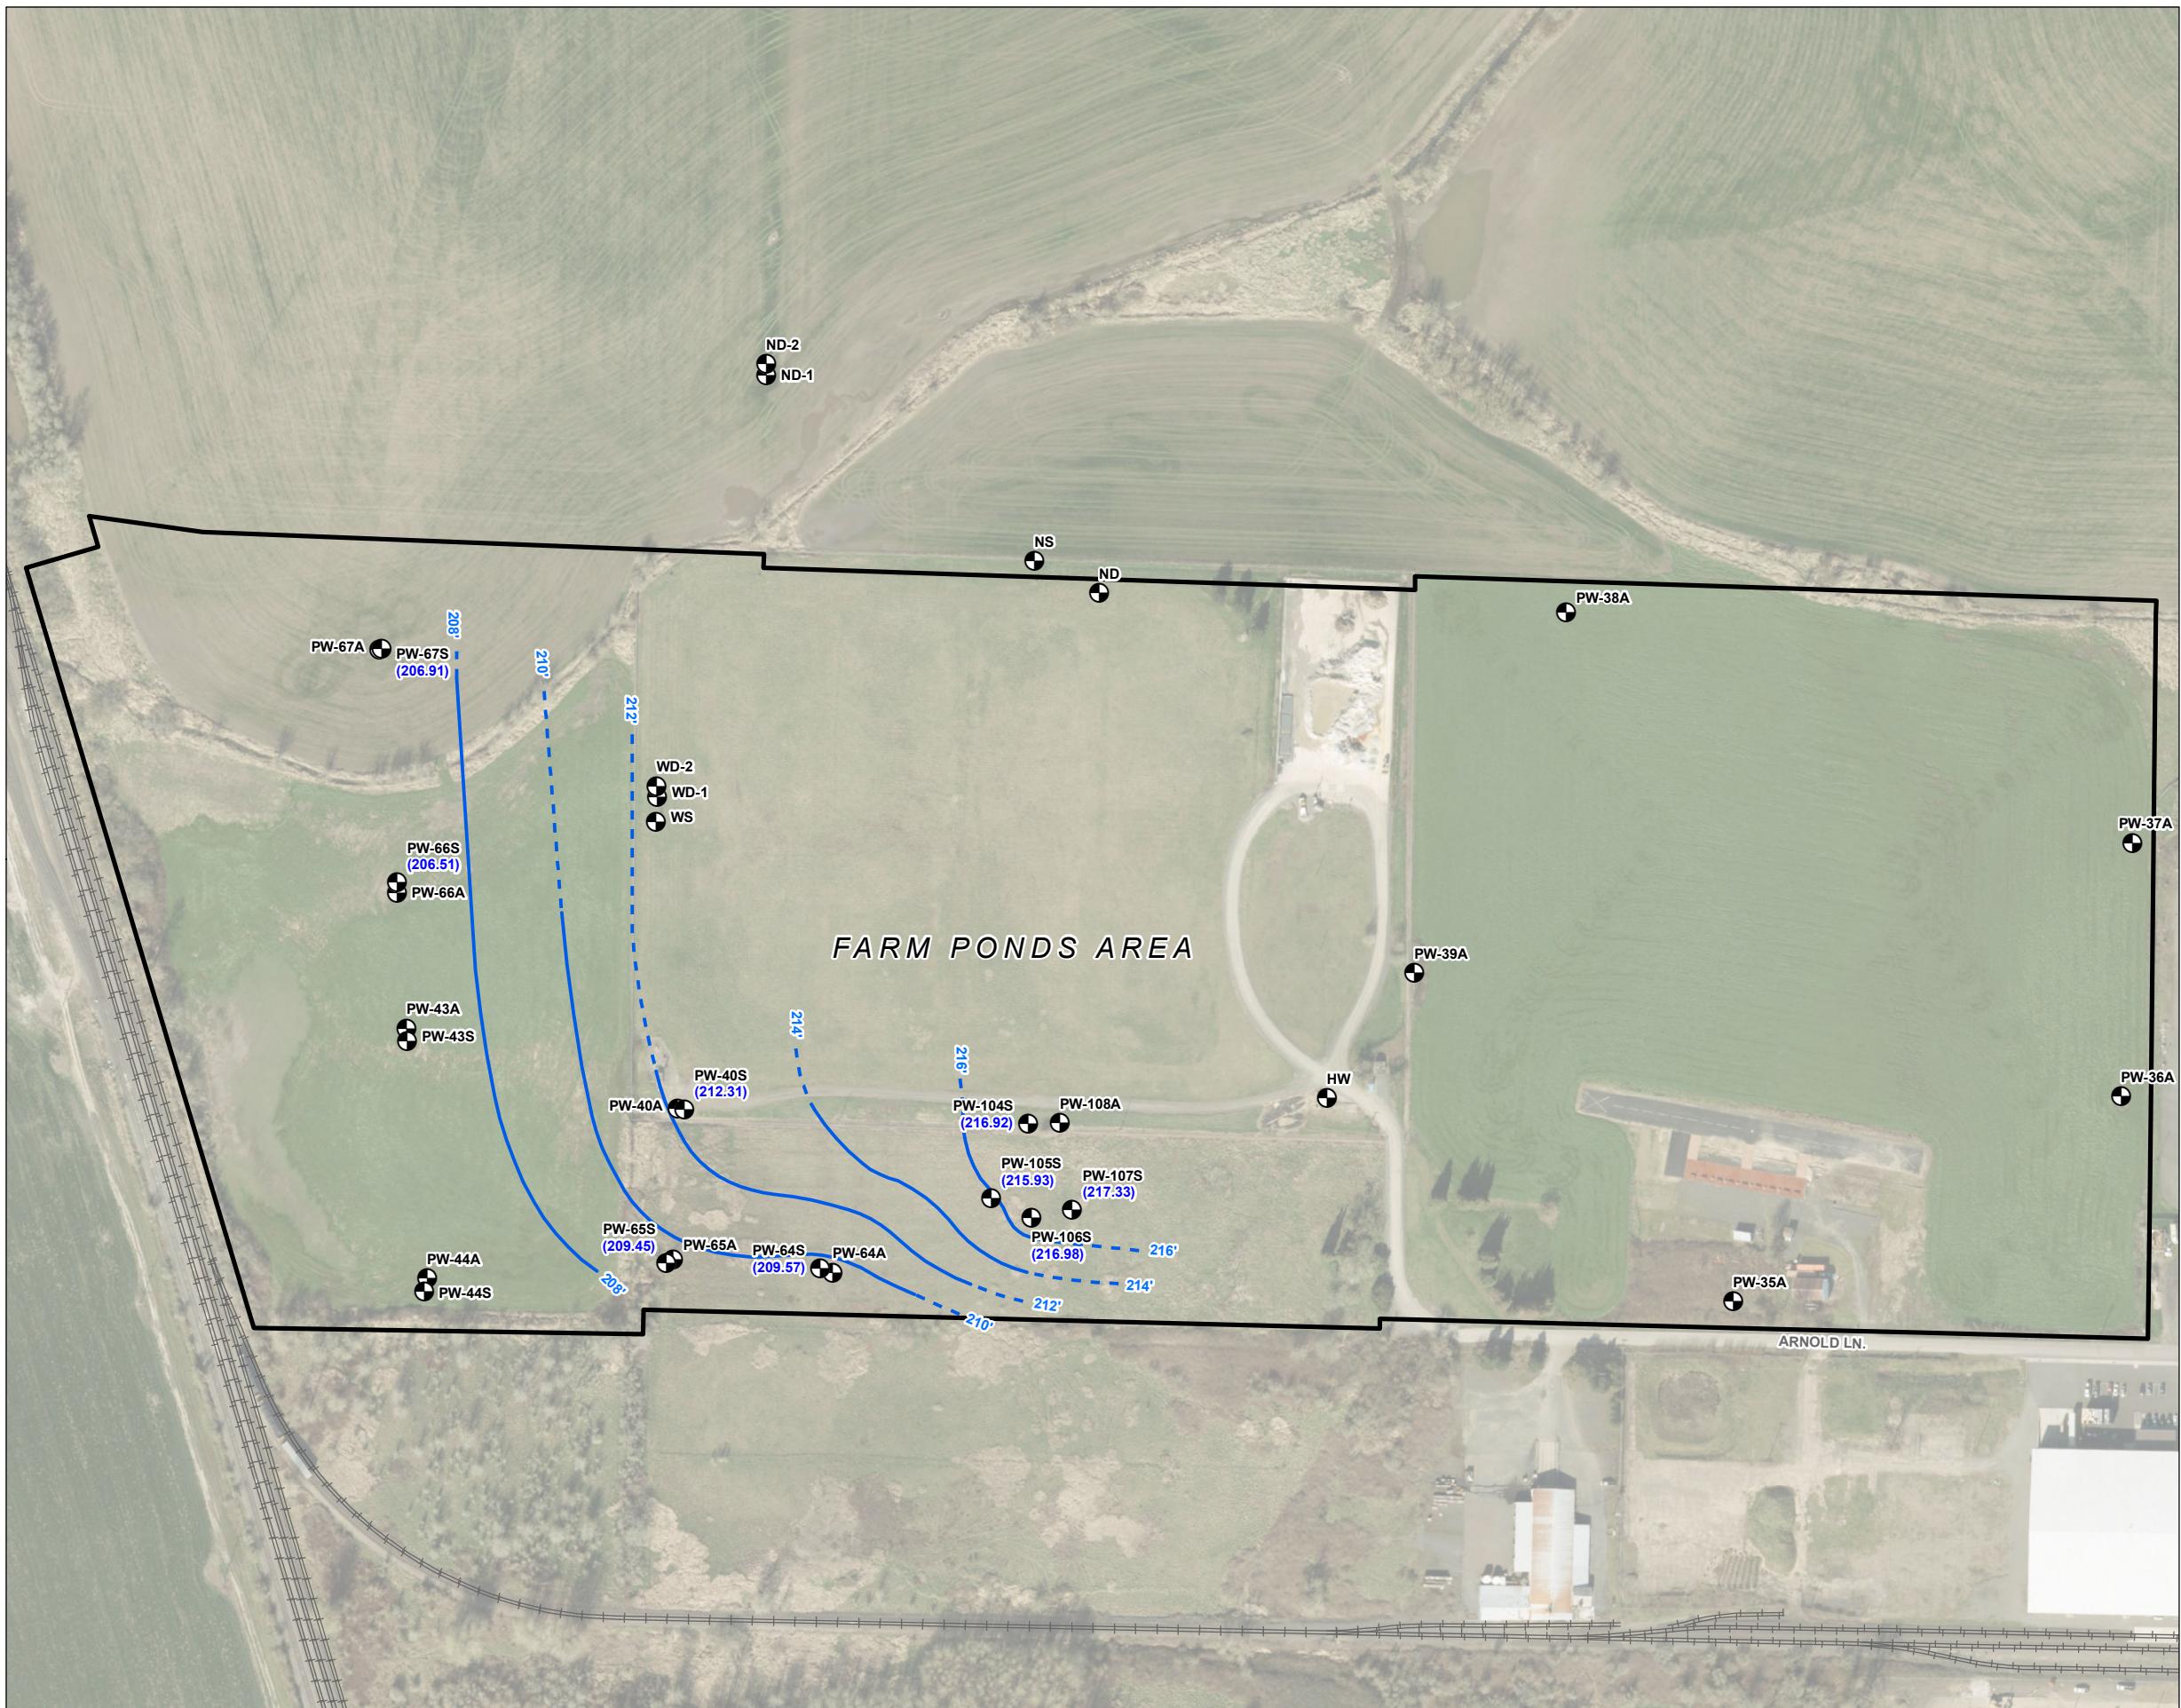
FIGURE 2

Groundwater flow direction in the Willamette Silt was generally to the southwest during the 2018 monitoring event, as shown in Figure 2.

**Groundwater Contours
2018 Annual Monitoring Event
ATI Millersburg Operations, Oregon**

- The groundwater flow direction in the Willamette Silt (including PW-104S) is generally to the southwest. PW-40S and PW-60S, which are downgradient of PW-104S to the west, have not had any CVOC detections exceed a cleanup standard since 2008. PW-105S, PW-106S, and PW-107S, which are downgradient of PW-104S to the southeast, south, and southwest, respectively, have recorded no CVOC detections above the laboratory reporting limit since installation in 2016.

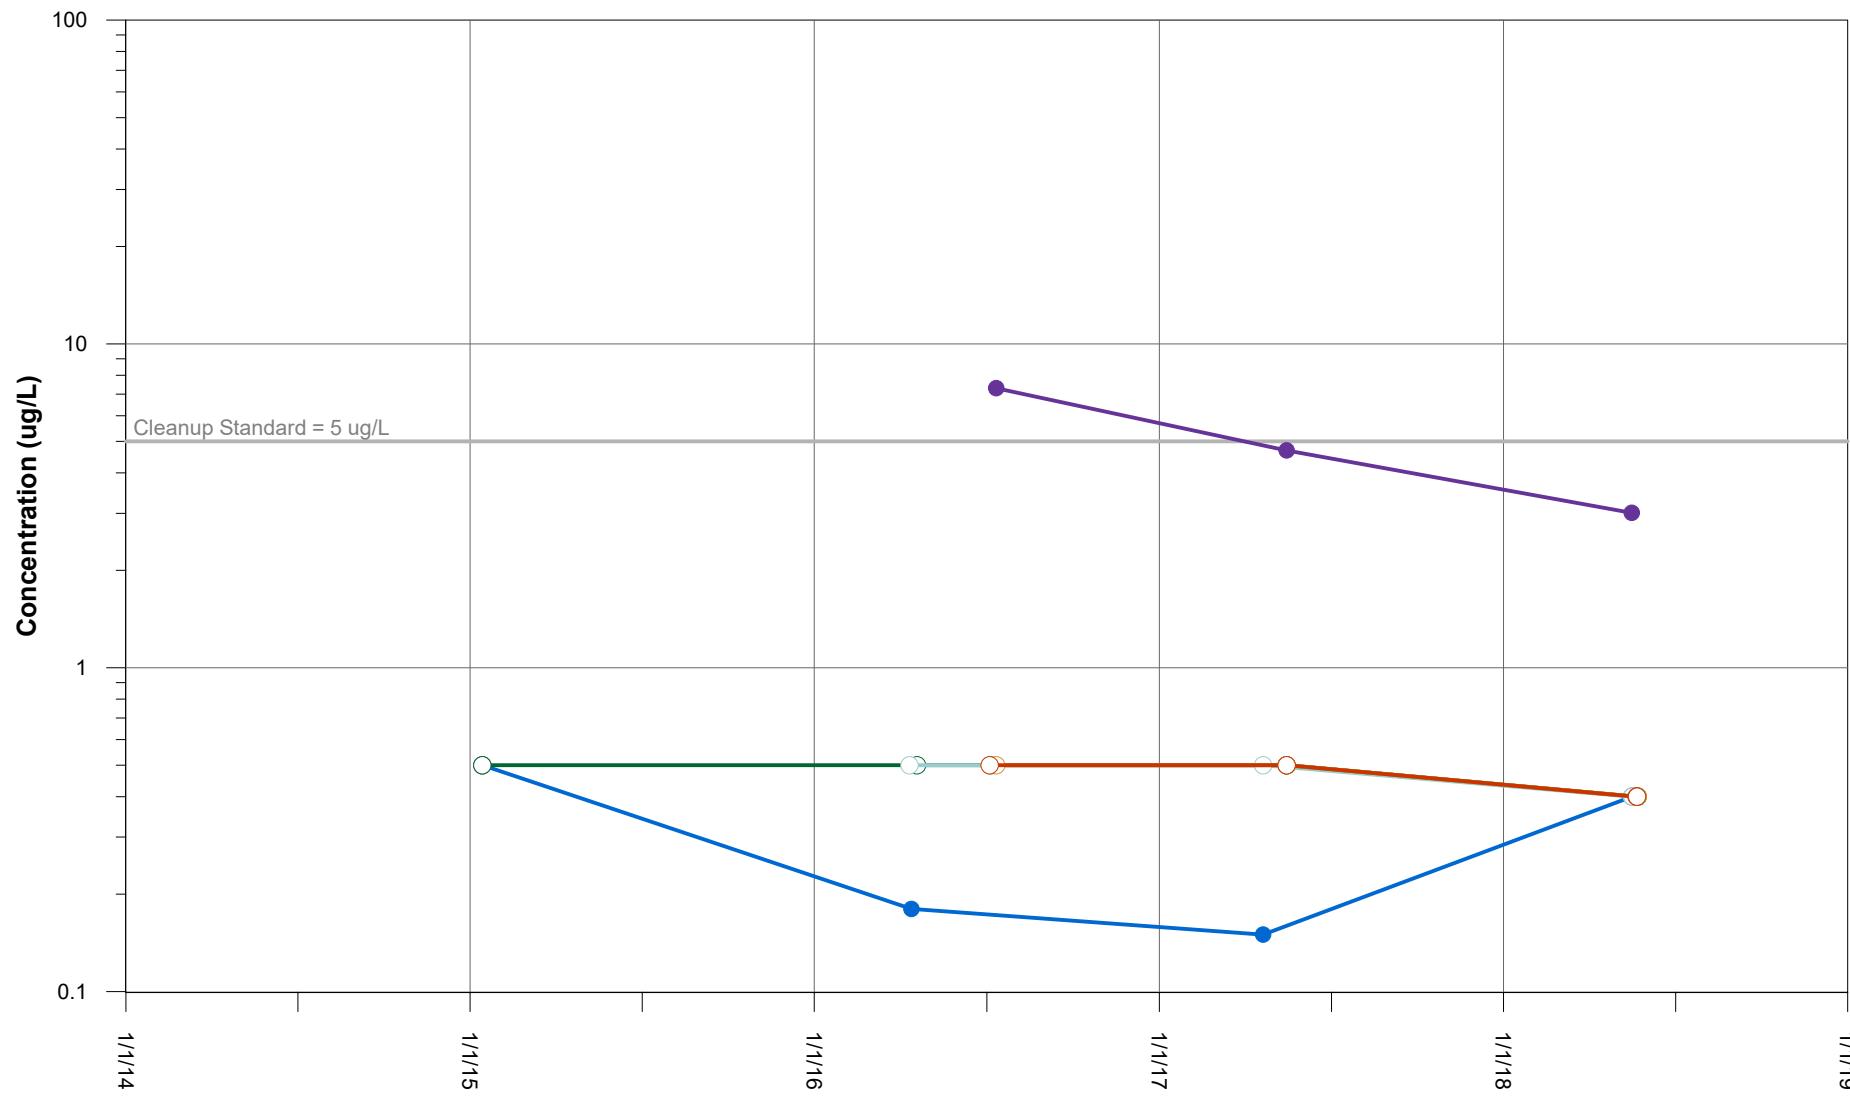
FIGURE 3
Farm Ponds Area
Tetrachloroethene Concentration Trends, 2014-2018
ATI Millersburg Operations, Oregon

The PW-104S concentration of PCE (3.01 micrograms per liter [$\mu\text{g}/\text{L}$]) remained below the cleanup standard of 5 $\mu\text{g}/\text{L}$ and continued the downward trend established in 2017 (Figure 3). Figure 4 shows the downward trend of TCE in PW-104S (7.60 $\mu\text{g}/\text{L}$), although the concentration exceeded the cleanup standard of 5 $\mu\text{g}/\text{L}$. The concentrations of 1,1,2-TCA (8.96 $\mu\text{g}/\text{L}$) and 1,2-DCA (6.74 $\mu\text{g}/\text{L}$) at PW-104S exceeded the applicable cleanup standards (3 $\mu\text{g}/\text{L}$, and 5 $\mu\text{g}/\text{L}$, respectively) and remained relatively stable from 2017 (Figures 5 and 6, respectively).

- In PW-104S, there was a downward or stable trend for all detected CVOCs (Figures 3 through 6):
 - TCE was detected at 7.6 $\mu\text{g}/\text{L}$ in 2018, which is less than the detections in 2017 (10.9 $\mu\text{g}/\text{L}$) and 2016 (19 $\mu\text{g}/\text{L}$).
